Title No. 113-S31

Testing of Reinforced Concrete Frames Extracted from a Building Damaged during the Canterbury Earthquakes

by Kevin Walsh, Richard Henry, Gye Simkin, Nicholas Brooke, Barry Davidson, and Jason Ingham

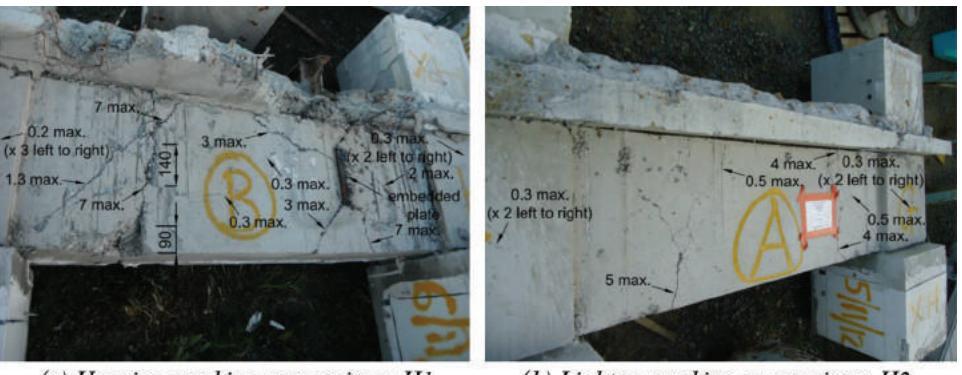
Damage to the H-frame specimens from the 2010-2011 Canterbury earthquakes can be seen in Fig. 3. Contrary to the original design intent of the "shear-ductile" link, but consistent with the results of previous experimental testing on similarly detailed specimens¹³ and strut-and-tie analysis,^{10,11} both H-frame specimens sustained the most extensive damage approximately 500 mm (19.7 in.) from the column face, near the locations where the reinforcement was bent to form the diagonal (indicated in Fig. 2(a) by the position of the steel stirrup plates). Residual crack widths at these locations were as large as 7 and 5 mm (0.28 and 0.20 in.) in Specimens H1

(a) Heavier cracking on specimen H1

(b) Lighter cracking on specimen H2

Fig. 3—Post-earthquake damage to H-frame specimens with crack widths indicated. (Note: All units in mm; 1 mm = 0.0394 in.)

and H2, respectively, as shown in Fig. 3. Multiple large cracks in Specimen H1 protruded from the location of an embedded steel plate (visible to the right in Fig. 3(a)), which was included in the unit to connect the perimeter frame to the interior gravity frame (Fig. 1(b)). Diagonal cracks in the beam-column joint region of both H-frame specimens were typically less than 0.3 mm (0.01 in.) wide and only superficial cracking was observed in the columns.

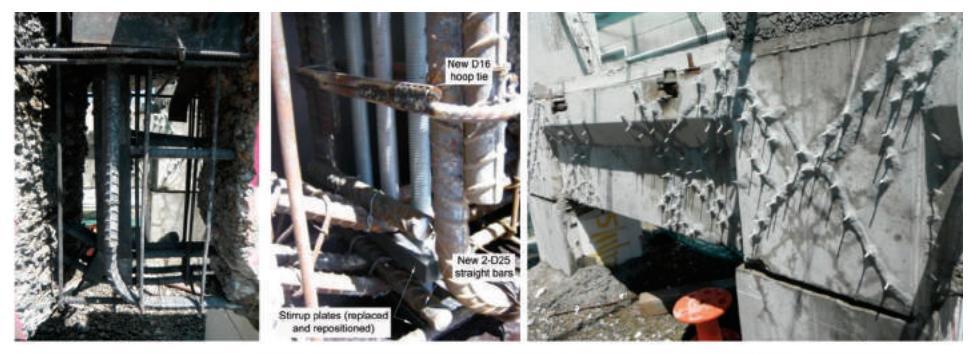
(a) Heavier repairs on (b) Retrofit of specimen specimen H1 (hydraulic H1 demolition and reinstatement)

(c) Lighter repairs (crack injection) on specimen H2

Fig. 4—Repair of earthquake damage to H-frame specimens.

Specimen H1 was taken from the most damaged region of the exterior building frame—the north side of the eighth floor—where in-place repair and retrofit of the beams would likely have been required had the building not been deconstructed. To verify whether Clarendon Tower could have been repaired to a state of structural integrity equaling or exceeding its capacity prior to the earthquakes, repairs were commissioned for Test Specimen H1 in the manner in which they would have been proposed on the in-place structure. Specimen H1 was repaired and retrofitted based on a technique previously validated in New Zealand¹³ and consisted of the following steps:

1. Concrete surrounding the steel stirrup plates was removed using hydrodemolition to avoid damaging the reinforcing steel (refer to Fig. 2(a) and Fig. 4(a));

2. Additional transverse reinforcement consisting of D25 bars (where "D" represents "deformed" bar, and the diameter is 25 mm [0.98 in.]) was placed at the inside of each bend of the original D24 (0.94 in.) diagonal reinforcement bars to improve bearing strength at these locations (refer to Fig. 2(a) and Fig. 4(b));

3. The steel stirrup plates shown were replaced and repositioned so that bearing stresses were more evenly distributed between inner and outer bent D24 (0.94 in.) bars (refer to Fig. 2(a) and Fig. 4(b));

4. Transverse hoop ties consisting of D16 (0.63 in.) bars were added around the vertical legs of the hooks formed where the D32 (1.26 in.) reinforcement bars terminated at the interface with the diagonal reinforcement detail (refer to Fig. 2(a) and Fig. 4(b)); and

5. Flowable concrete with a nominal compressive strength of 60 MPa (8.7 ksi) was used to reinstate the concrete removed via hydrodemolition.

Specimen H2 was taken from the less damaged south frame where it experienced minor to moderate cracking, as shown in Fig. 3(b). Epoxy injection was used to repair the H2 specimen, as shown in Fig. 4(c), and no further retrofit enhancements were used. Likewise, Specimen C1 (composed of Beams C1N and C1S denoting relative orientations "north" and "south" on the building per Fig. 1(b)) sustained only minor to moderate cracking during the earthquakes, as shown in Fig. 5. Specimen C1 had begun to be prepared for crack injection after the September 2010 earthquake, as shown in Fig. 5(a), but repairs were not completed prior to the February 2011 earthquake and subsequent demolition of the building. Due to the preparation for repairs, the widths of larger residual cracks in the beam ends near the joint could not be measured reliably. Other residual crack widths in the beams and beam-column joint region were generally less than 0.3 mm (0.01 in.). As with the H-frame specimens, no measureable cracking was observed in the column outside the joint region. As the damage to the cruciform beams was not anticipated to affect their structural performance, Beams C1N and C1S did not receive any further repair prior to testing, such that these specimens were tested in their post-earthquake-damage state. Repair of these frames in-place would only have been required for reasons of cosmetics and durability.

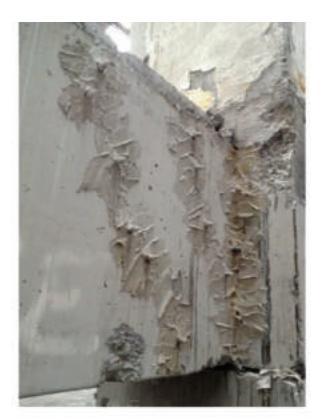
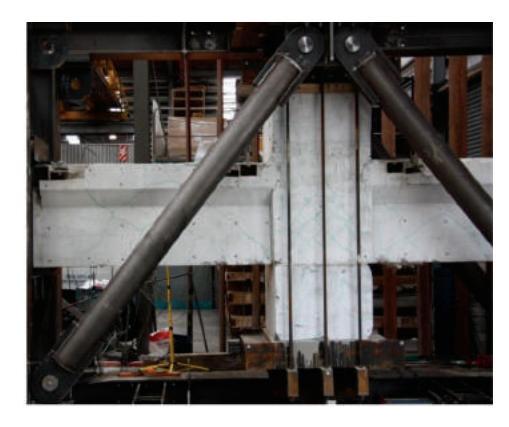
(a) Residual damage and uncompleted repairs on the interior (east) face of the south beam (C1S)

(b) Residual cracks marked on the exterior (west) face

Fig. 5—Post-earthquake damage to cruciform frame specimen.

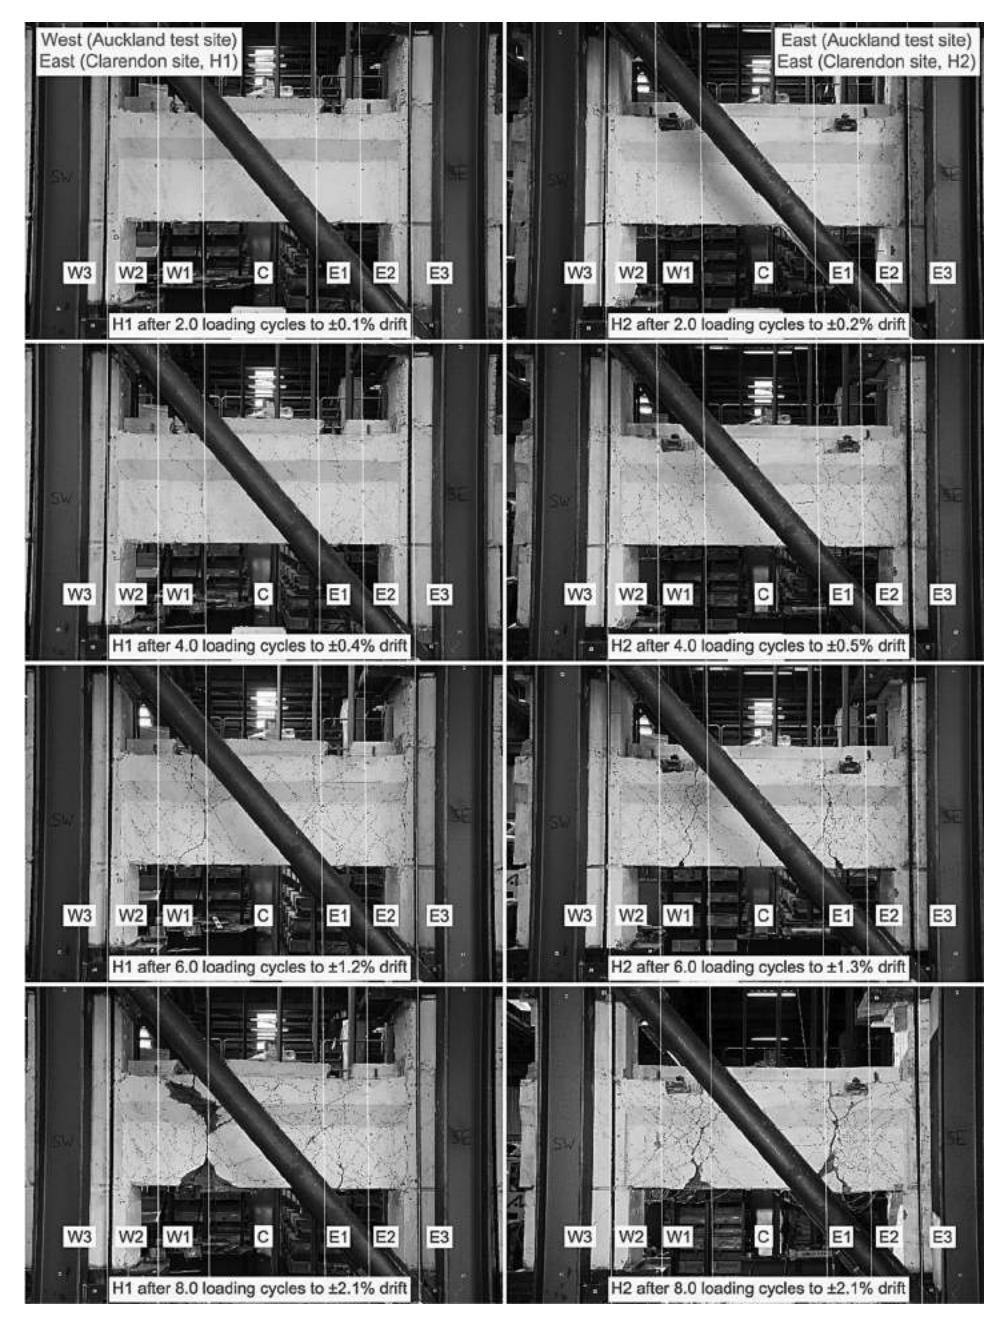
Images of damage state conditions at progressively larger drift cycles for Specimens H1 and H2 are shown in Fig. 8. At

low drift levels, flexural cracks formed near the beam ends and propagated at approximately 45 degrees through the web region of the beam due to the high shear demand in the short span. Flexural cracks at the bottom edge of the beams were reasonably well distributed, approximately corresponding to the stirrup spacing. Flexural cracks at the top edge of the beams were less uniformly distributed and concentrated at two to three wider cracks due to the presence of embedded steel plates and anchors associated with the exterior cladding. After drift demands of approximately $\pm 1.2\%$ were reached, wide cracks started to open up in both H-frame specimens approximately 500 mm (19.7 in.) from the beam ends at the location where the "bend" of the diagonal reinforcement occurred (refer to Fig. 2(a)). During subsequent cycles, the damage was concentrated at these locations, which is consistent with the locations on the beams that were most damaged occurred during the 2010-2011 earthquakes (refer to Fig. 3). The locations of damage concentration were bounded by displacement gauge panels E1 and W1 (refer to Fig. 8). The cracks at these locations reached widths exceeding 8 mm (0.31 in.) at maximum drifts of approximately $\pm 2.0\%$, and a shear-sliding mechanism became visibly prominent. In the case of the H1 specimen, damage caused by shearsliding was especially and narrowly concentrated within the region of the beam bounded by panel W1, with significant spalling occurring during cycles to $\pm 2.1\%$ drift. In the case of the H2 specimen, damage was more evenly distributed between both ends of the beam, resulting in more symmetrical spalling and loss of concrete cross-section within gauge panels E1 and W1.

Despite the design intent for the plastic hinges to be concentrated at the "shear-ductile" link with diagonal reinforcement at the central panel region (C), only relatively minor cracking occurred in this region for both H-frame specimens. The lack of observed damage to the central "shear-ductile" link was consistent with the design deficiency that was discovered during previous testing of this type of detail,¹³ and it appeared that the repair to the H1 test specimen did not prevent the damage from concentrating at the location of the bar bends. No primary longitudinal steel reinforcing bars were observed to have ruptured during the testing of either H-frame specimen, although some primary longitudinal bars were deformed vertically (that is, transversely to their originally longitudinal axes) during the development of the shear-sliding mechanisms.

Fig. 8—Damage state conditions at progressively higher drift levels for H1 (left, repaired, and retrofitted) and H2 (right, repaired only) specimens with approximate portal gauge panel regions indicated (gauges physically located on opposite side of specimens).

3. Deformation and damage in the H-frame beams were due largely to the development of shear-sliding mechanisms located in the regions near the "bend" in the diagonal beam reinforcement (refer to Fig. 2(a), 8, and 10), as previously observed in testing of precast RC beams with similar reinforcement details^{13,17} and predicted by analyzing these diagonal bar details using a strut-and-tie model^{10,11};

residual stiffness (refer to Fig. 9(a), 9(b), and 9(d), respectively). However, the retrofit technique used in Specimen H1 did not prevent shear-sliding mechanisms in gauge panel regions E1 and W1 from occurring (Fig. 8), contrary to the retrofit design intent; and

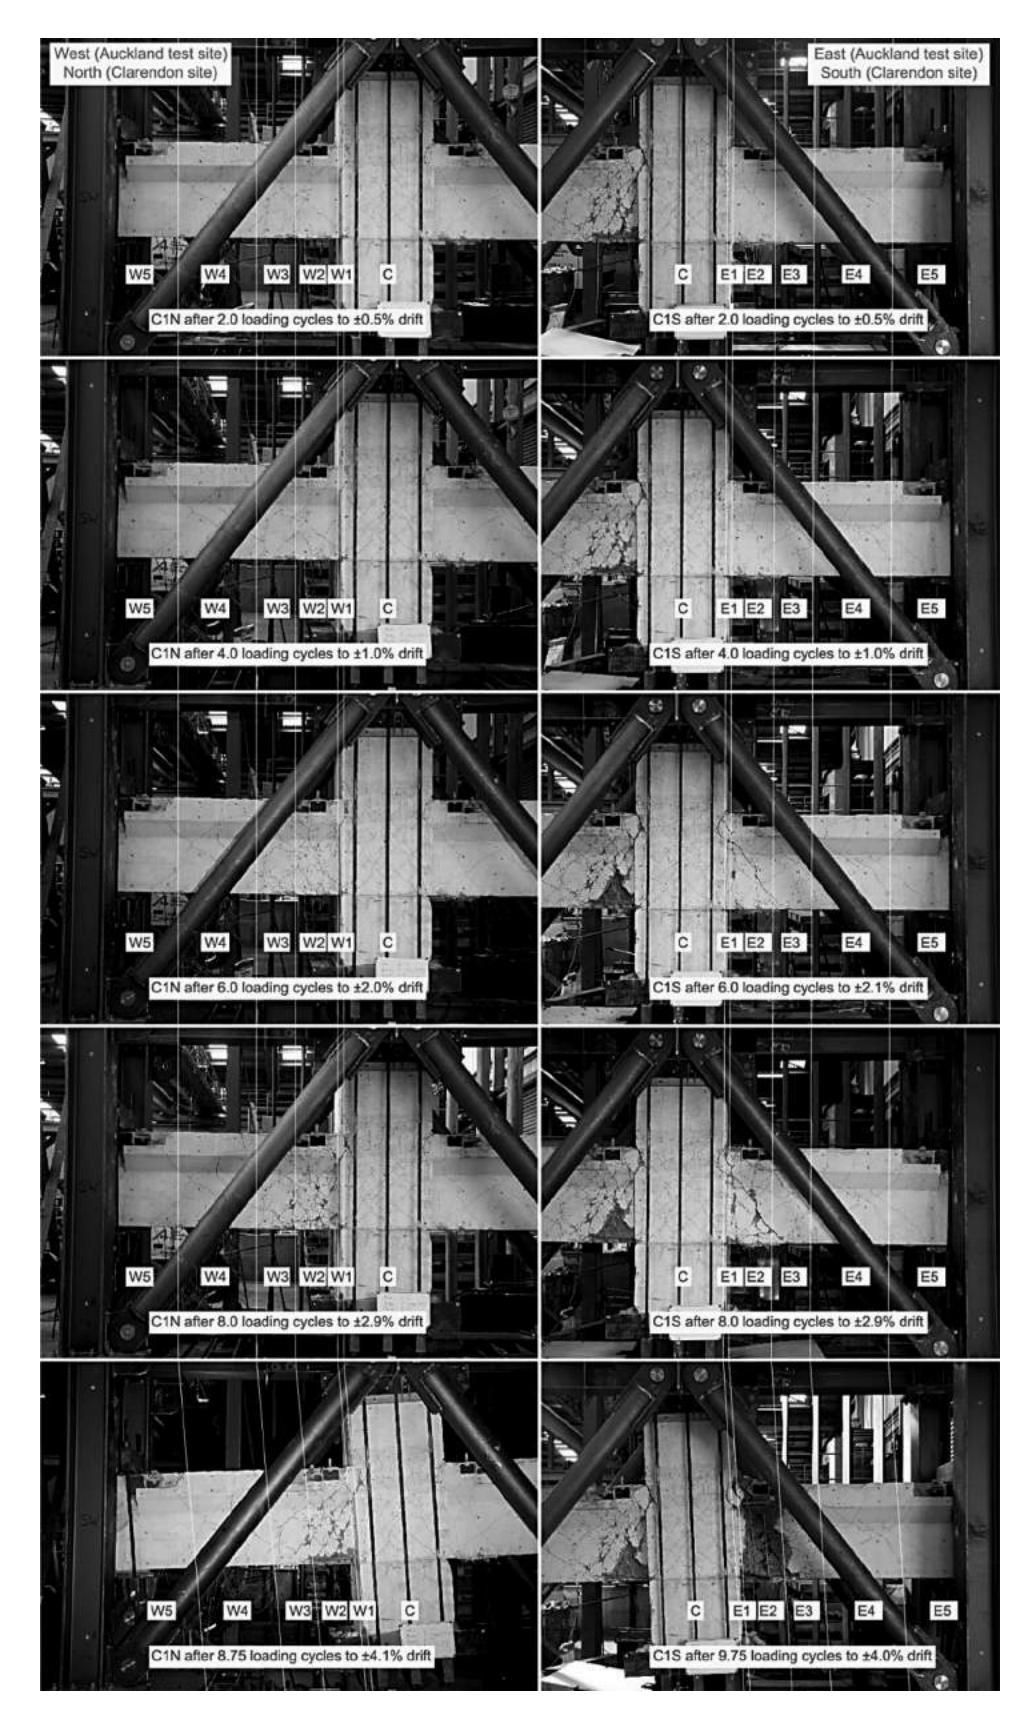
Images of damage state conditions at progressively larger drift cycles of Specimens C1N and C1S are shown in Fig. 11. The damage pattern was consistent for the two cruciform beams, as would be expected due to their similar detailing. As with the H-frame beams, flexural cracks formed at low drifts with relatively regular spacing corresponding to the stirrup spacing at the bottom of the beams. Initial flexural cracks at the top of the beams were less uniformly distributed and corresponded with areas stiffened by embedded plates and anchors originally installed for connecting exterior cladding to the frame (refer to Fig. 5(b)). Damage concentration in the intended plastic hinge regions¹⁹ at the beam ends near the column (E2 and W2 in Fig. 11) became prominent at drifts of approximately $\pm 2.0\%$, at which point primary flexural cracks in these regions opened to widths exceeding 8 mm (0.31 in.). Moderate spalling in the beam end regions, primarily due to concrete crushing, occurred at drift levels of approximately \pm 3.0%. More significant spalling occurred at drift levels of approximately $\pm 4.0\%$.

The greater extent of damage in C1S at the conclusion of testing (observable in Fig. 11) was due to this unit having been tested to two cycles of drifts at $\pm 4.0\%$ as compared to Beam C1N, which was tested to only one cycle of drifts at $\pm 4.0\%$. As a result, the more prominent buckling of the primary longitudinal reinforcement observed in Specimen C1S was likely associated with complete spalling of the cover concrete around almost the entire circumference of the beam in the end region (E2). At the end of the test, it was observed that one of the top longitudinal reinforcing bars of both beams (C1N and C1S) had been completely cut through approximately 100 mm (3.94 in.) from the face of the column during the process of the specimen's removal from Clarendon Tower, resulting in slightly greater crack openings at the top of the beams as compared to the underside of the beams at similar drifts. Aside from the saw-cut reinforcement, no primary longitudinal steel reinforcing bars were observed to have ruptured during the testing of either cruciform beam specimen.

Fig. 11—Damage state conditions at progressively higher drift levels for C1N (left) and C1S (right) beam specimens with approximate portal gauge panel regions indicated (gauges physically located on opposite side of specimens).

4. Deformation and damage in the cruciform beams was due largely to the development of a flexural plastic hinge at the beam ends near the joint region, as is expected in typical moment-resisting RC frames¹⁹;
