Title No. 113-S53

# Seismic Repair of Severely Damaged Precast Reinforced Concrete Bridge Columns Connected with Grouted Splice Sleeves

by Joel E. Parks, Dylan N. Brown, M. J. Ameli, and Chris P. Pantelides

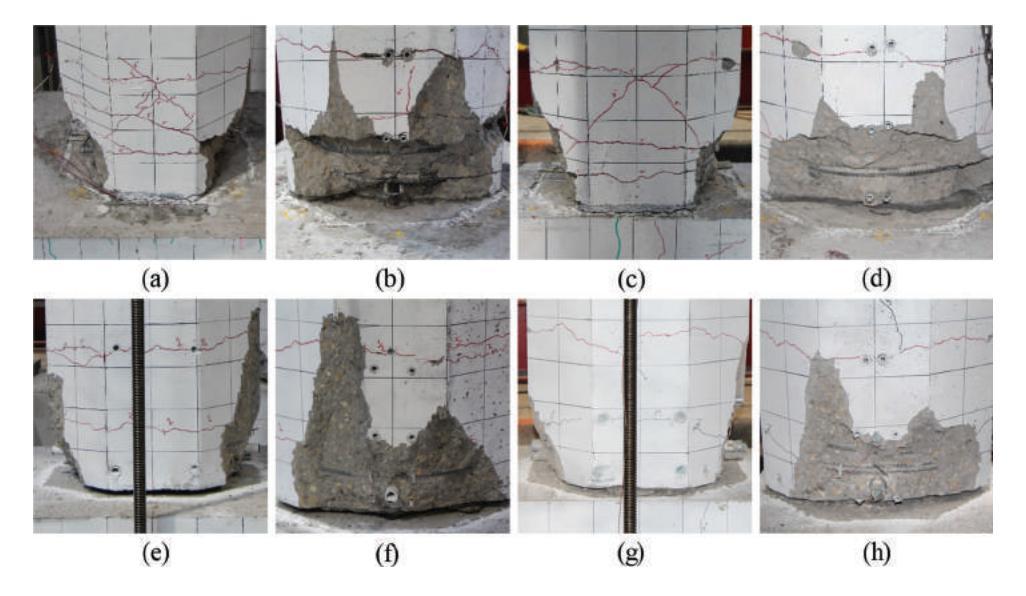
the ultimate load. The reserve lateral load capacity of the original columns after testing ranged from 44 to 65% of the maximum lateral load capacity. Figure 4 shows the original column damage at the footing-to-column and column-topier cap interfaces, where extensive spalling and cracking occurred in the plastic hinge region. All original specimens experienced flexural cracking, which extended to 14 in. (356 mm) away from the footing or pier cap interface.

To assess the damage state of the original specimens a five-level performance evaluation approach was used.<sup>20</sup> This assessment procedure was based on the performance of the structure, which is defined by a particular damage state, and is classified into five levels. Level 1 is equivalent to no damage, and Level 5 is equivalent to local failure or collapse. According to this type of assessment, the four original specimens have reached a damage state designation of Level 5 because rein-

forcing bar fracture or pullout from the GSS occurred, thus significantly compromising the lateral load-carrying capacity of the columns. Structural components with a damage level of 5 usually require replacement. However, with the repair method developed, repair of precast columns connected using GSS connectors with Level 5 damage is possible.

Fig. 4–Original specimen damage: (a) NM-O1 (front); (b) NM-O1 (side); (c) LE-O1 (front); (d) LE-O1 (side); (e) NM-O2 (front); (f) NM-O2 (side); (g) LE-O2 (front); and (h) LE-O2 (side).

to a column cross section that has minimal damage. From the observed damage of the four original specimens shown in Fig. 4, a repair height of 18 in. (457 mm) was determined to be sufficient. In this case, there were two criteria to define the repair height. The first was to relocate the plastic hinge above any structural cracks equal to or larger than 0.01 in. (0.254 mm) wide, and the second was to provide enough height to develop the headed bars in tension.

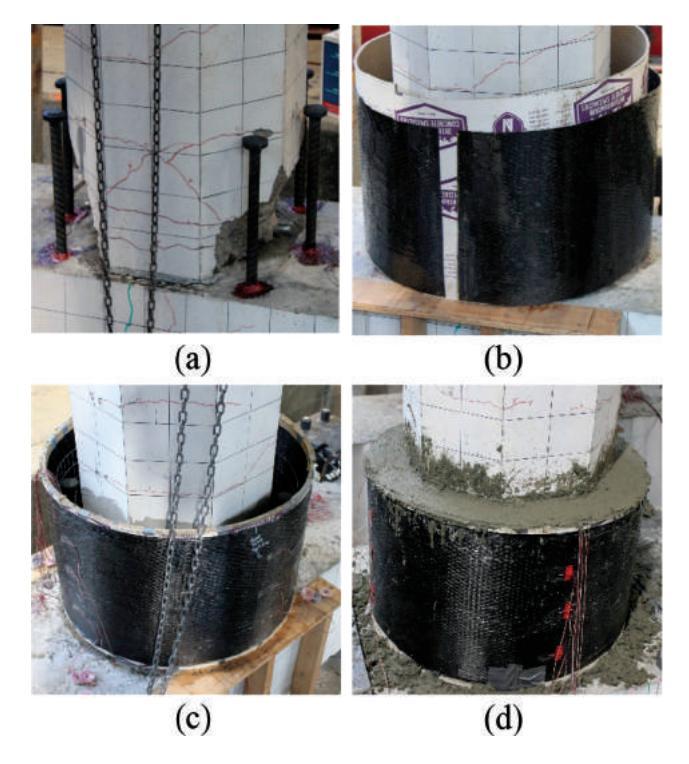
*Fig.* 7—*Repair procedure: (a) post-installed headed bars; (b) split CFRP shell; (c) CFRP shell around column; and (d) CFRP shell filled with nonshrink or expansive concrete.*

The first step in the repair procedure was to create a prefabricated CFRP shell. A single layer of 18 in. (457 mm) wide CFRP sheet impregnated with epoxy was wrapped and cured around a 30 in. (762 mm) diameter sonotube to create the proper shape. While the CFRP shell was curing, the holes for the headed bars were core drilled into the footing or pier cap and the headed bars were epoxy anchored into place around the column, as shown in Fig. 7(a). After the CFRP shell had cured, it was split into two half-cylinders and brought around the column, as shown in Fig. 7(b). The splitting and splicing of the first CFRP shell layer was performed to better simulate how the repair would be constructed in the field. A circular shell cannot be lowered over a column because the latter is connected to a footing and pier cap. The sonotube inside the shell in Fig. 7(b) was used to ensure that the shell maintained its shape, while the additional layers of CFRP were applied

and subsequently removed once all CFRP layers had cured. A 12 in. (305 mm) long by 18 in. (457 mm) wide piece of CFRP sheet impregnated with epoxy was used to splice the two halves of the CFRP shell on both sides. Once the first layer of the CFRP shell was spliced, three additional CFRP layers were added, as shown in Fig. 7(c). Each layer was 100 in. (2.54 m) long by 18 in. (457 mm) wide, with a 6 in. (152 mm) overlap for each layer. This was the last step in completing the construction of the CFRP shell which acted as stay-in-place formwork for the repair concrete. Once the CFRP shell had fully cured, nonshrink or expansive concrete was added to the space between the column and CFRP shell, as shown in Fig. 7(d).

For LE-O1 and LE-O2, the diameter of the repair was larger than the width of the pier cap. Wooden forms were placed alongside the pier cap to provide sufficient width for the repair, as shown in Fig. 7(b) and 7(c). The wooden forms were removed once the concrete had cured. In practice, the pier cap would be oriented above the column, and the gap between the repair and pier cap would provide an inlet for the concrete; the gap between the column and the repair would have to be sealed.

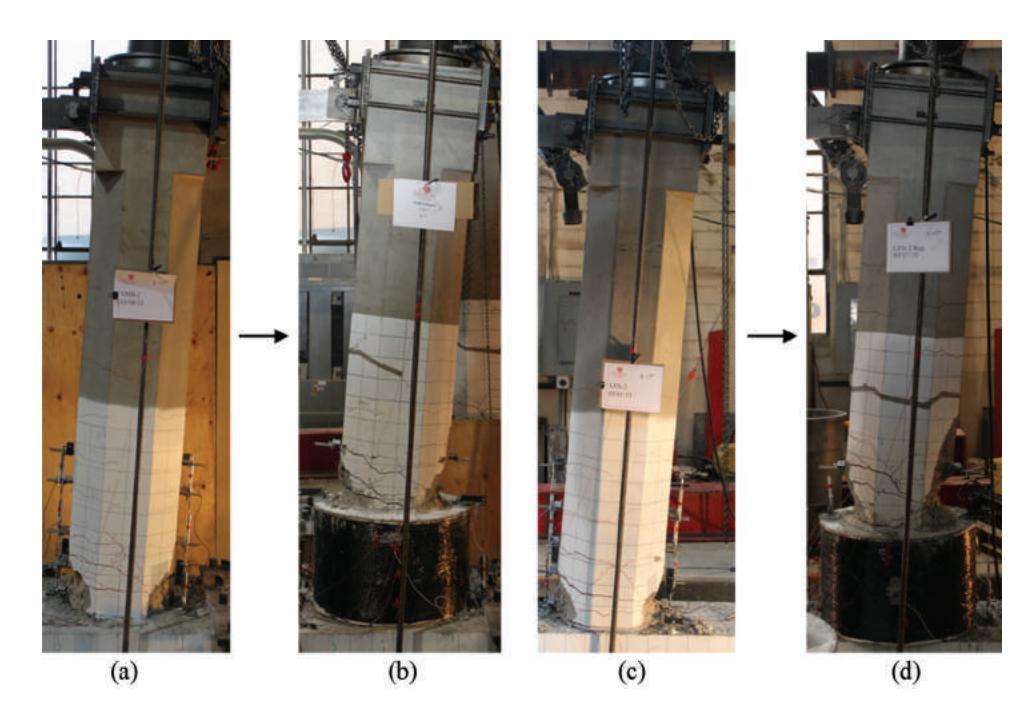
Fig. 9—Plastic hinge relocation: (a) NM-01; (b) NM-R1; (c) LE-01; and (d) LE-R1.

The test assembly and loading protocol remained unchanged for the original and repaired specimens. The strength and displacement capacity of the damaged bridge columns was restored by achieving the same displacement drift and lateral load as the original specimens. The successful plastic hinge relocation for NM-R1 and LE-R1 is shown in Fig. 9.

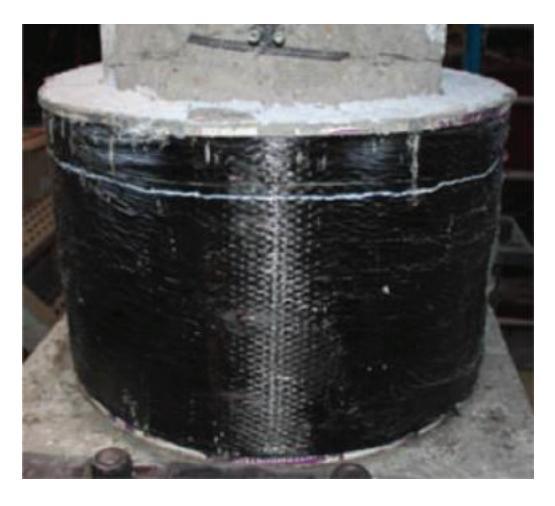
bar fractured in NM-O1. Figure 11 shows the circumferential CFRP crack traced with a white marker. The hysteretic response of the specimen was unaffected by the circumferential crack in the CFRP shell.

Fig. 11—Circumferential CFRP crack (NM-R1).

CFRP cracking parallel to the fiber direction occurred during the 4.2% drift step for both the NM-R1 and LE-R1 specimens. The circumferential CFRP crack was located approximately 3 in. (76 mm) below the top of the CFRP shell, which correlates to the top of the headed bars, and extended halfway around the jacket circumference. The circumferential CFRP crack also occurred on the side where the column longitudinal bar had fractured in NM-O1 and LE-O1. While the hysteretic response of both specimens remained unaffected from the circumferential crack in the CFRP, it did affect the performance of the CFRP shell. In Fig. 14(a), the CFRP shell engages in both directions until a sudden drop in

strain is observed at a drift of 4.2%, correlating to the onset of the circumferential crack. The crack occurred due to a lack of tension capacity in the repair concrete above the headed bars; this cracking could be mitigated by using bidirectional CFRP or fiber-reinforced concrete, which provides additional tension capacity perpendicular to the CFRP fiber direction.

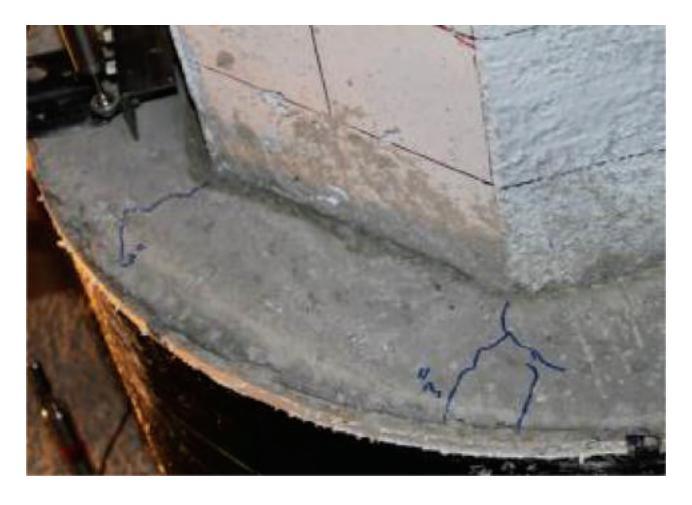
Fig. 15—Radial cracks in repair concrete (NM-R1).
