Title No. 113-S31

Testing of Reinforced Concrete Frames Extracted from a Building Damaged during the Canterbury Earthquakes

by Kevin Walsh, Richard Henry, Gye Simkin, Nicholas Brooke, Barry Davidson, and Jason Ingham

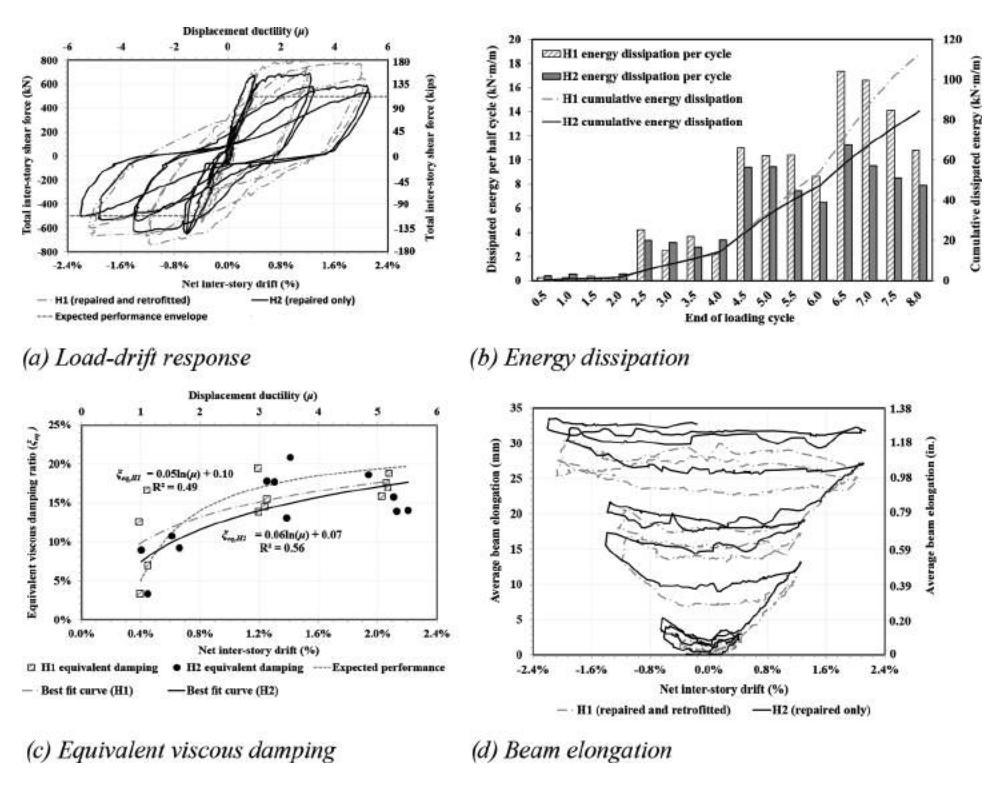
The global lateral force-drift response and calculated hysteretic energy dissipation of the two H-frame specimens are compared in Fig. 9(a) and Fig. 9(b), respectively. The repaired and retrofitted H1 specimen exhibited a higher strength (Fig. 9(a)) and greater energy dissipation at large drifts (Fig. 9(b)) when compared to the H2 specimen, which was repaired only with epoxy injection and more closely represented the as-built condition of the H-frame components prior to the earthquakes. The response of both H-frame specimens was not stable, and softened in terms of strength and energy dissipation capacity at subsequent cycles to equivalent drift levels. As shown in Fig. 9(a), the strength

of the H1 test specimen decreased by approximately 10% during the negative portion of the first cycle of loading to a drift of -2.1% and by approximately 20% for both loading directions during the second cycle to a drift of $\pm 2.1\%$. The strength of the H2 test specimen decreased by approximately 15% during the second cycle of loading to a drift of $\pm 1.3\%$, sustained this reduced load capacity during the first cycle to a drift of $\pm 2.1\%$, and then decreased further to approximately 20% below the initial peak strength during the second cycle to a drift of $\pm 2.1\%$. Testing of each unit was concluded after the completion of two reversed loading cycles to an approximate drift of $\pm 2.1\%$, approximately equivalent to a displacement ductility $\mu = 5.2$. As shown in Fig. 9(a), pinching occurred in the hysteresis loops of both H-frame specimens (but especially the non-retrofitted H2 specimen) due to the

prominence of shear-sliding mechanisms at higher drifts, limiting the energy dissipation capacity of the H-frames at higher drift levels. The pinching in the hysteresis response was more evident for the H2 specimen, with the H1 specimen displaying somewhat greater energy dissipation.

Fig. 9—Comparison of global performance of the two H-frame test specimens. (Note: 1 kN = 0.225 kip.)

responses in Fig. 9(a). The strength of both H-frame specimens measured during testing exceeded the calculated yield strength. This difference was attributed to the effects of strain aging in the steel reinforcement, which likely resulted from the preceding earthquake demands, which were especially high on the north and south frames from which the tested H-frame specimens were extracted. It should also be noted that the frames would potentially have had greater capacities within the building due to the contribution of the floor diaphragm to the flexural strength.

The energy dissipation per half cycle (Fig. 9(b)) was determined from the corresponding hysteresis area (Fig. 9(a)). The energy dissipation was then converted to an equivalent viscous damping per half cycle, with the results plotted in Fig. 9(c) for Test Specimens H1 and H2. Retrofitted specimen H1 exhibited slightly higher equivalent viscous damping at lower drifts than Specimen H2, corresponding to larger hysteresis loops at lower drifts (Fig. 9(a)). However, the equivalent damping for the H1 and H2 specimens was similar at higher drifts. The expected equivalent damping performance graphed in Fig. 9(c) was determined using the method proposed by Priestley et al.¹⁹ for more typically detailed RC frames. Note that Specimens H1 and H2 had equivalent viscous damping capacities slightly less than typical RC frames at high displacement ductility demands, most likely due to the presence of a shear mechanism with pinched hysteresis behavior as opposed to a more desirable and conventional flexural inelastic mechanism.

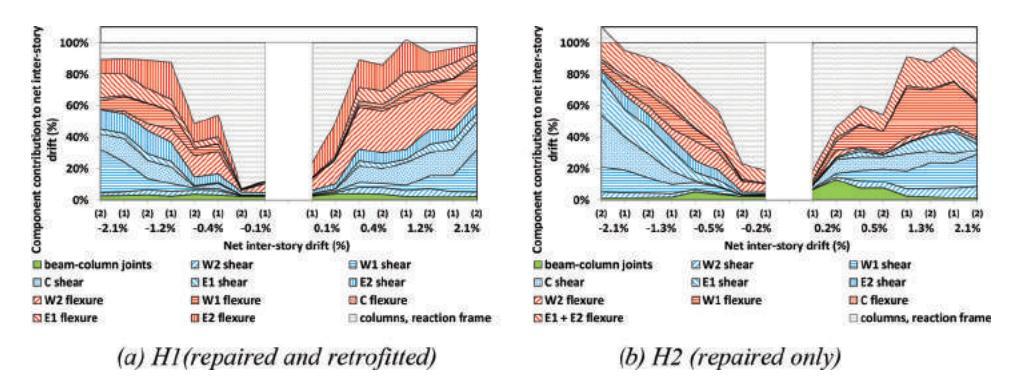
The contributions of local deformation components to the total interstory drifts of the H-frame specimens (measured using the gauge setup shown in Fig. 7(a)) are plotted in Fig. 10. Note firstly that flexural mechanisms, particularly at the ends of the beams by the columns (Panels E2 and W2), contributed more to interstory lateral displacement at lower drifts, and that the contribution from shear mechanisms became more prominent at higher drifts. On both

Fig. 10—Component contributions to interstory drifts of H-frame specimens.

H-frame specimens at high drift demands, the center panel region (C) contributed less to total frame deformation than intended by its shear-ductile design,¹³ and the beam end regions (E2 and W2) contributed less to total frame deformation than in traditional moment-resisting frame design.¹⁹ The locations of prominent deformation mechanisms at high drifts occurred within gauge panel regions, E1 and W1, on both H-frame specimens. The more symmetric distribution of shear deformation in Panels E1 and W1 in Specimen H2 at high drifts (refer to Fig. 10(b)) as compared to the greater concentration of shear deformation in Panel W1 in Specimen H1 (Fig. 10(a)) was likely due to the presence of an embedded steel plate in the W1 region of Specimen H1 (Fig. 1(b) and Fig. 3(a)). Measured deformations within the beam-column joint regions contributed relatively little to the total interstory drifts of both H-frame specimens.

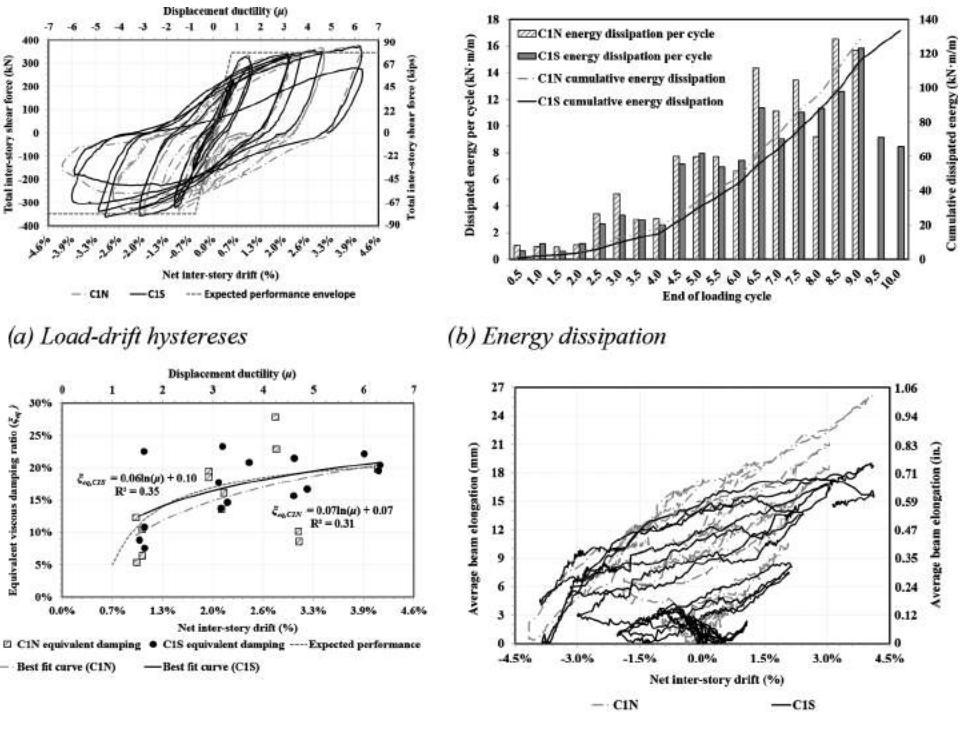
was approximately 60% and 40% higher than predicted for specimens H1 and H2, respectively (refer to Fig. 9(a)), likely due to strain aging of the longitudinal reinforcement. The anticipated interstory shear yield drift and strength of the cruciform beams was 0.5% and 347 kN (78 kip), respectively, using a simplified, empirically based procedure^{18,19} and traditional RC beam cross-sectional analytical procedures, respectively. A slightly higher, but similar, yield drift

Fig. 12—Comparison of global performance of two cruciform test specimens. (Note: 1 kN = 0.225 kip.)

of 0.65% and a nearly equivalent interstory shear strength were measured for both cruciform beams during testing (refer to Fig. 12(a));

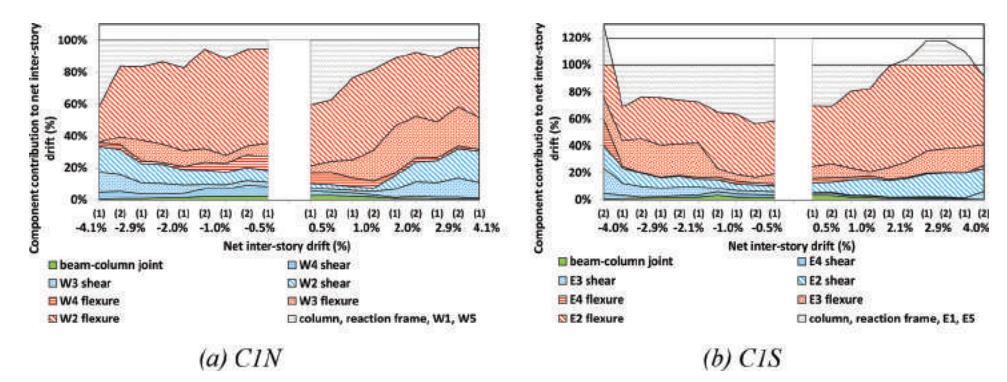
Fig. 13—Component contributions to interstory drifts of cruciform specimens.
