John J. Earley's Mosaic Concrete

Meridian Hill Park and Edison Memorial Tower

by Anne E. Weber, Paul E. Gaudette, and Robert F. Armbruster

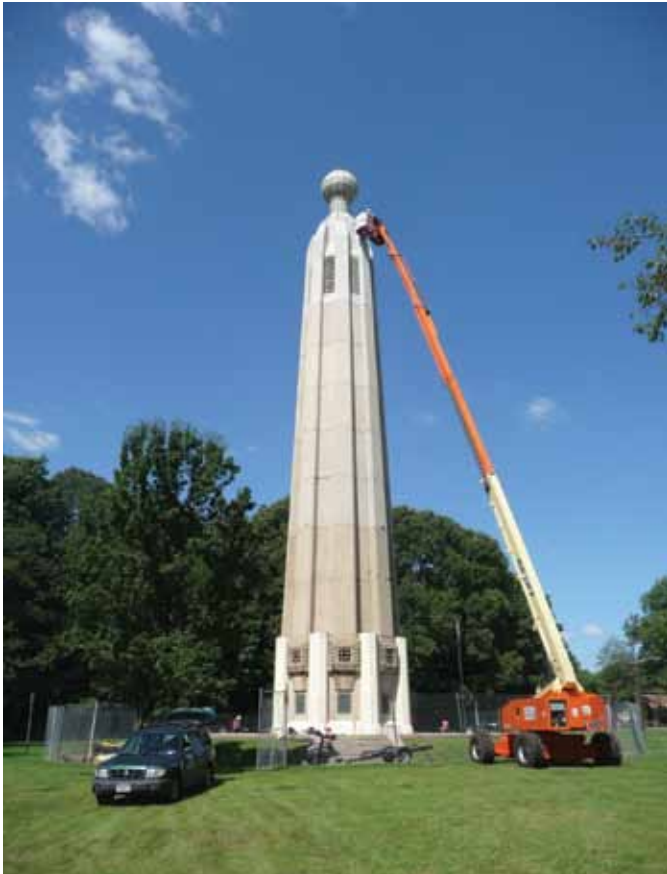
With its concrete heavily deteriorating, the state of New Jersey hired Mills + Schnoering Architects, LLC, to restore the Edison Tower. Field investigations in 2009 revealed that some panels, mostly the ones at the top, had to be completely replaced (Photo courtesy of Mills + Schnoering Architects, LLC)

The field survey revealed that the structure and the mosaic concrete panels were generally sound, requiring only isolated patching. The lowest and uppermost levels of the monument were more severely deteriorated and damaged, and required full replacement of the precast concrete panels. The limited deterioration in the shaft of the tower was primarily the result of corrosion of embedded reinforcing steel or freezing-and-thawing deterioration at panel joints. The deterioration at the buttresses at the base of the monument was due to freezing-and-thawing deterioration of the concrete backup mixture.

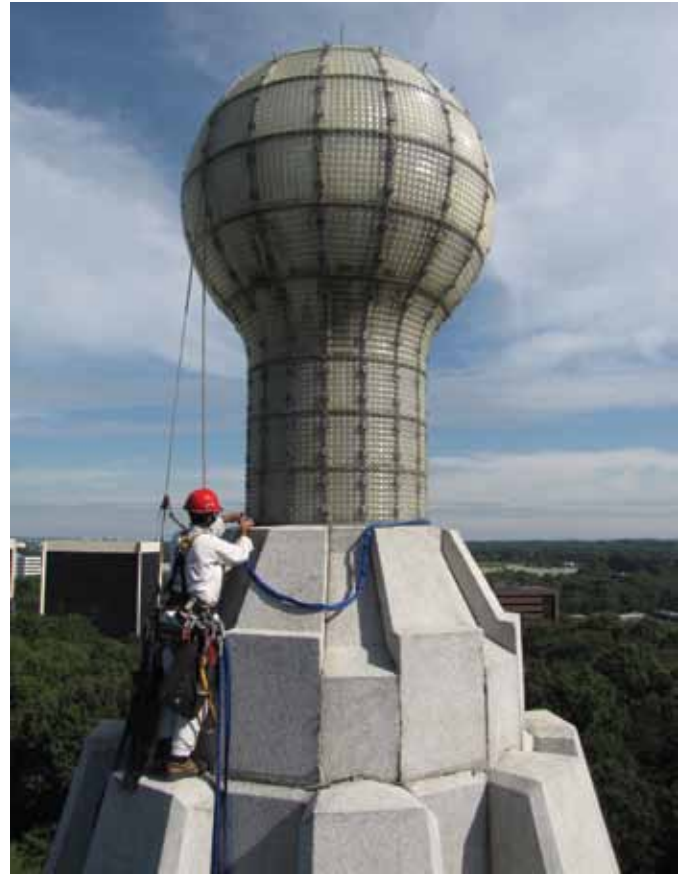
The concrete panels at the top of the Edison Tower are white with a cobalt blue color so they match the color of the sky. Closer inspection reveals the scale of the Pyrex replica of the light bulb. The light bulb will also be cleaned as part of the restoration process (Photo courtesy of Mills + Schnoering Architects, LLC)

From the base of the tower to the top, the mosaic panels transition from amber to cream to brilliant white to, ultimately, white panels tempered with cobalt blue that stand out against the sky. Earley combined three colors of aggregates for each panel to create a painterly effect. To create the dark panels at the base of the towers,

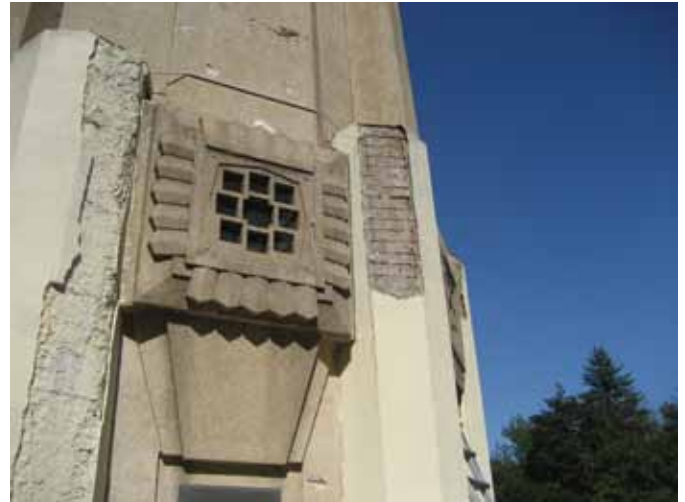
Field investigations at the Edison Memorial Tower revealed a range of deterioration caused by two factors: corrosion of the embedded reinforcing steel and cycles of freezing and thawing (Photo courtesy of Mills + Schnoering Architects, LLC)

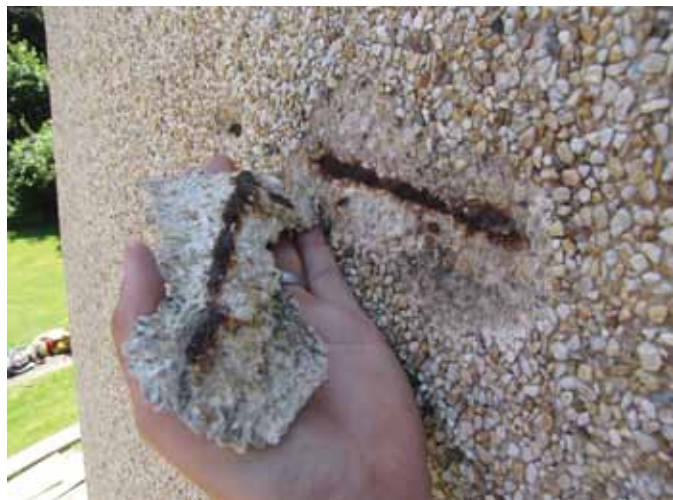
A corroded reinforcing bar behind the exposed aggregate concrete facing of the Edison Memorial Tower (Photo courtesy of Mills + Schnoering Architects, LLC)

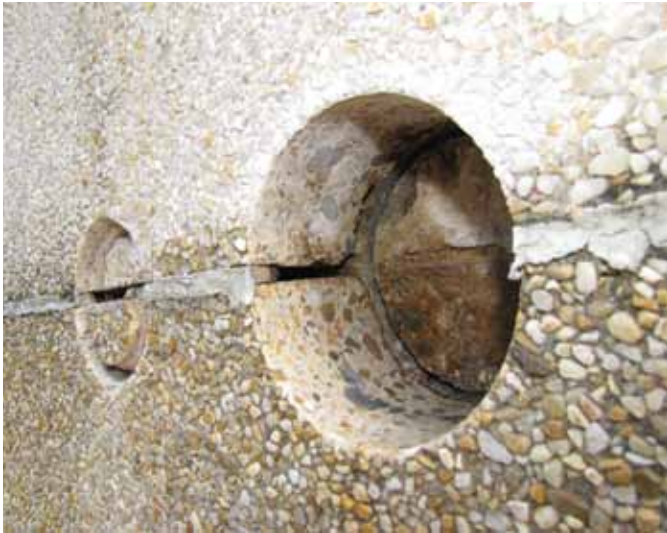
Concrete cores were taken from the Edison Monument to allow for laboratory analysis of the panel concrete. Panels were composed of a face mixture and a backup mixture. The panels served as the exterior forms for reinforced concrete that provides structural support of the monument (Photo courtesy of Mills + Schnoering Architects, LLC)

Concrete cores were extracted from the Edison Monument for laboratory analysis to determine the causes of deterioration, to better understand the characteristics of the concrete, and to assist in the development of the mixture design for the architectural concrete repairs.

The mosaic concrete panels were made up of two primary layers—a face mixture and a backup mixture—

with a total thickness of approximately 2-1/4 in. (57 mm). Both mixtures were non-air-entrained, as would be expected of concrete of this vintage. Only limited evidence of alkali-silica reaction (ASR) was detected, but no deleterious expansion was observed. Samples removed from the buttresses at the base consisted of a concrete that contained red and black glass in the coarse and fine aggregates. No evidence was found that this layer of material had suffered from ASR or damage from freezing and thawing; however, the backup mixture behind this layer suffered from severe damage from freezing and thawing.
