Resolving “Sweating” in Open Industrial Concrete Floor Slabs

Problems may be linked to using floors as a casting surface

by Arthur W. McKinney

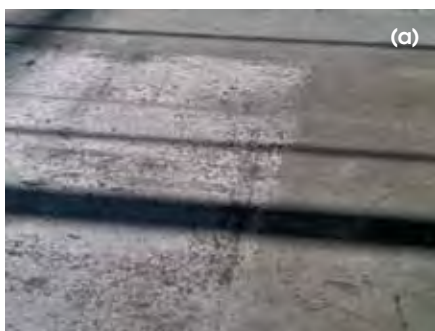
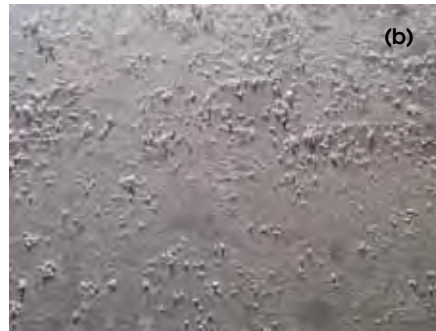
Fig. 1: In many cases, surface moisture problems are associated with the formation of a powder or crystalline residue in areas where tilt-up wall panels were cast: (a) general view of casting area on floor slab; and (b) close-up of crystals

- When drying occurs, white powder, filaments, or crystals may be left on the surface. These have been identified as carbonation products of alkali salts precipitating out of solution. Frequently, such material defines the extent and pattern of tilt-up panels or other components cast on the floor (Fig. 1).

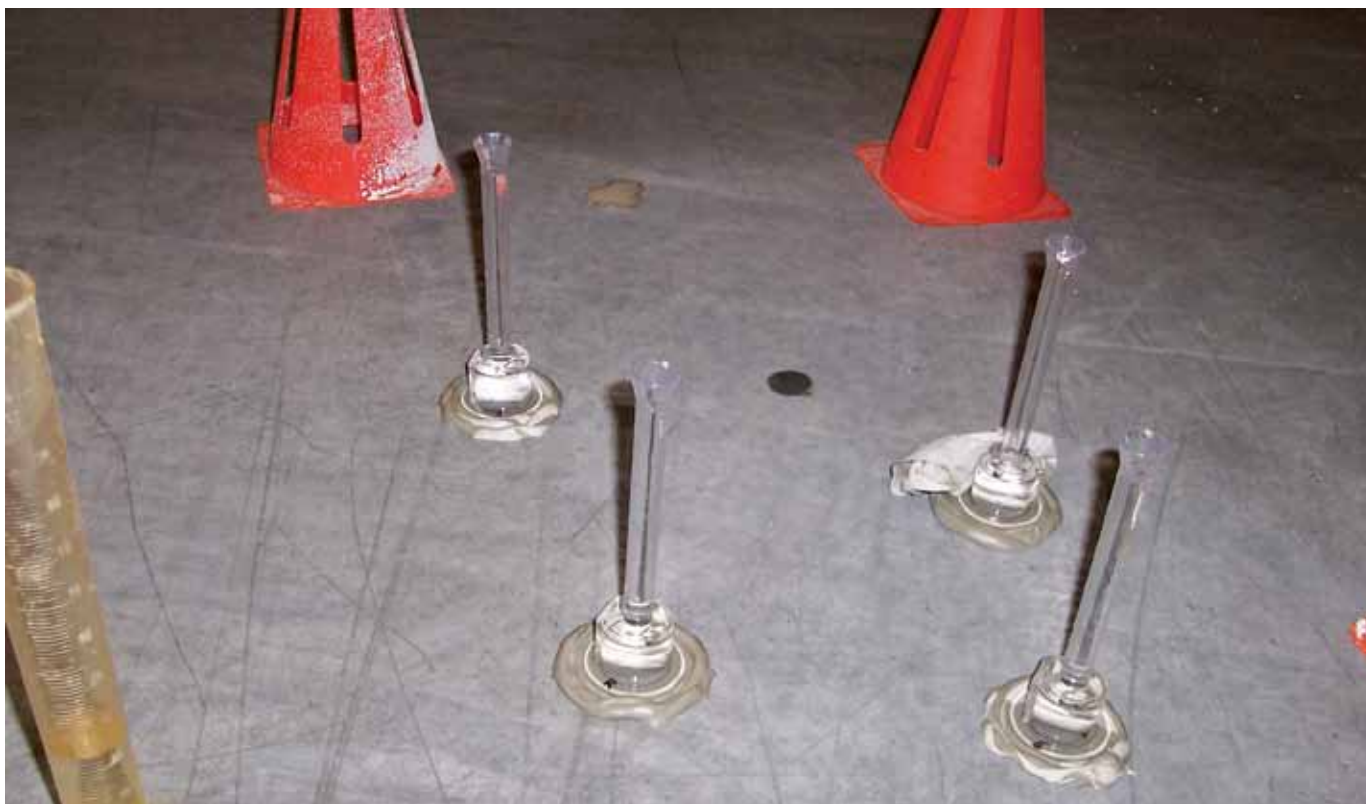
Fig. 2: Testing for relative absorption using Rilem tubes. In this case, four tubes were used at each test site/cycle

9. After each step, test the floor for water penetration and compare the results with the test area. In recent tests, Rilem tubes have been tried to assess relative improvements in surface absorption. The tubes were sealed to the floor and evaluated over a 2-hour period (Fig. 2). Rilem tubes on concrete can produce erratic results, but multiple tests suggest significant improvement after cleaning.
10. Allow to dry or revacuum.
